# T-509 ACOUSTIC EMISSION TESTING

14/07/2016

T-509 (Olefins Depentaniser Tower) is around 35m tall with 50 internal trays installed.

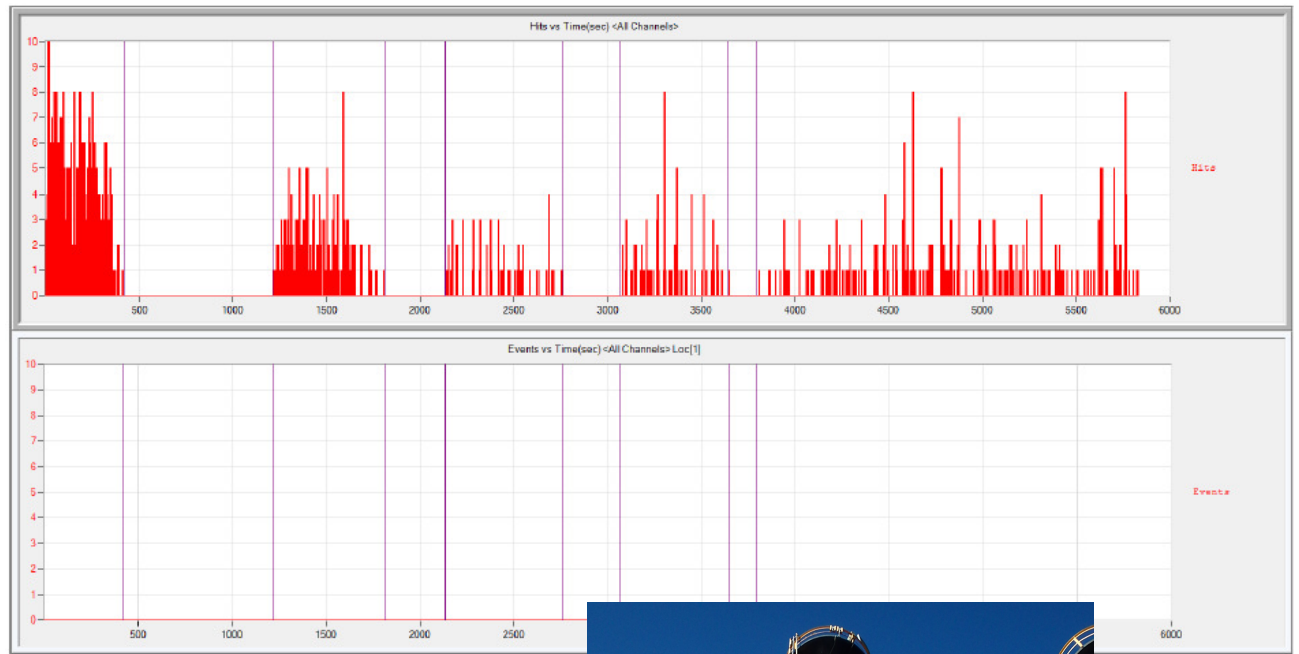
Located AE events.

- T-509 inspection completed within one day (with one day either side to prepare the tower)
- Total cost of around \$18K (\$17K for inspection)
- AE testing did not identify any active cracking defects
- Testing was completed in a timeframe significantly less than for full entry, and at a fraction of the cost.
- There was no exposure to Benzene or other harmful components as part of preparation or entry requirements
- Minimal flaring requirements for preparation and no waste disposal.
- No entry required – eliminated confined space hazards, manual handling risks, working at heights
- Opportunity for future T-509 testing as well as other vessels at Olefins (and other sites)
